1947-53 Chevrolet truck cup holders

Thank you for your purchase. These cup holders have been designed specifically for the stock grills in the 1947-53 Chevrolet trucks. The existing speaker system located in the stock center grill location can be retained and no drilling, cutting is required.

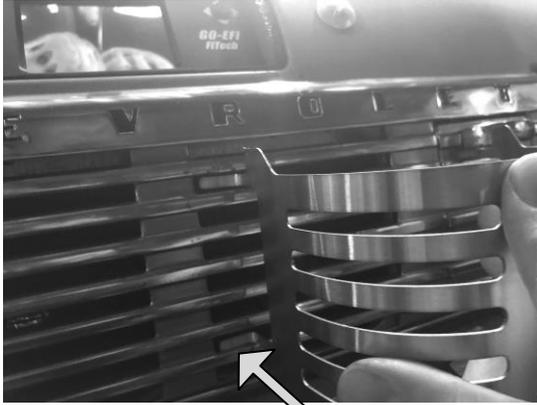
**LONG TABS
TOWARDS
INSIDE**

Step 1 - Hook the **long tab** side in first (Long tabs always go to the center grill section)

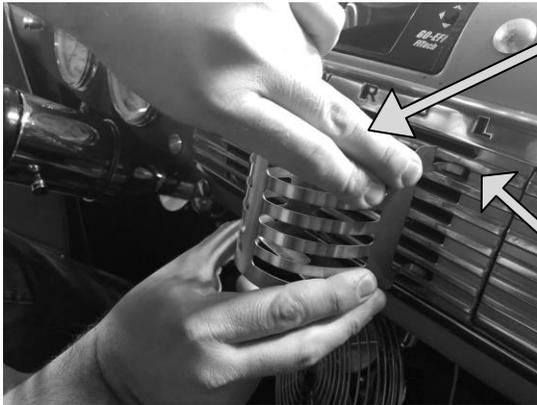
**USE 2 HANDS
TO INSTALL**

**SHORT TABS
TOWARDS
OUTSIDE**

Step 2 - Gently squeeze till the **short tabs** can clear the grill side and rotate the holder in and gently simply gently release.

Note: Mishandling and excessive force when squeezing these units can cause the units to deform. It is best to install as directed using two hands as shown in the attached pictures. This will give you better control and ensure you do not accidentally over squeeze. **Minor** deformation due to over squeezing can be easily corrected by carefully flexing the holder in the opposite direction. **Folding the unit in half by over squeezing is neither a manufacturing discrepancy nor a flaw in the product.**

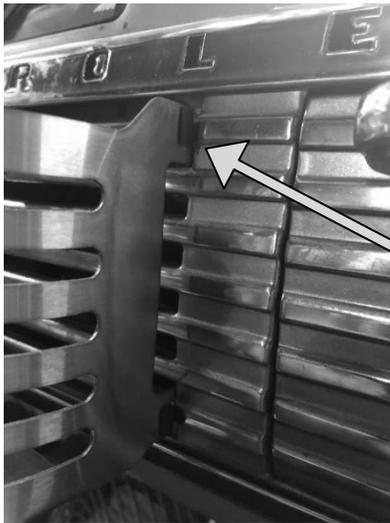
**VERIFY FULL
CONTACT**

Step 3 - Visually ensure holder has fully expanded and is making full contact on the sides.
